THIN-LAYER PLACEMENT PROJECT SHEET

Silver Lake

August 2016

Type: Sediment remediation/thin layer capping

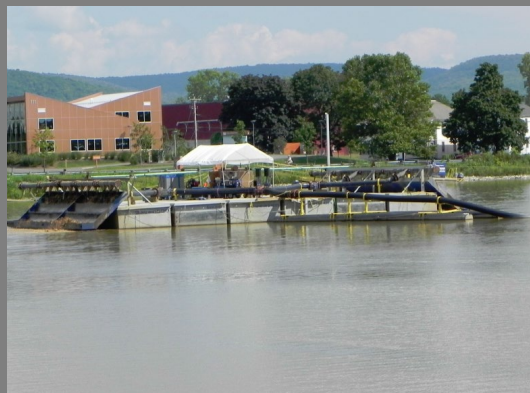
Taken from USEPA website, 2013 Citizens Coordinating Council Meeting
